Secure plug connections with cable ties.

Artikel-Nr.: SP41N, SP60
Hersteller: Krömer
EAN-Code: 0757284118791
0738964857155

Problem: Plug connections loosen during operation on the mobile 1-post lift.

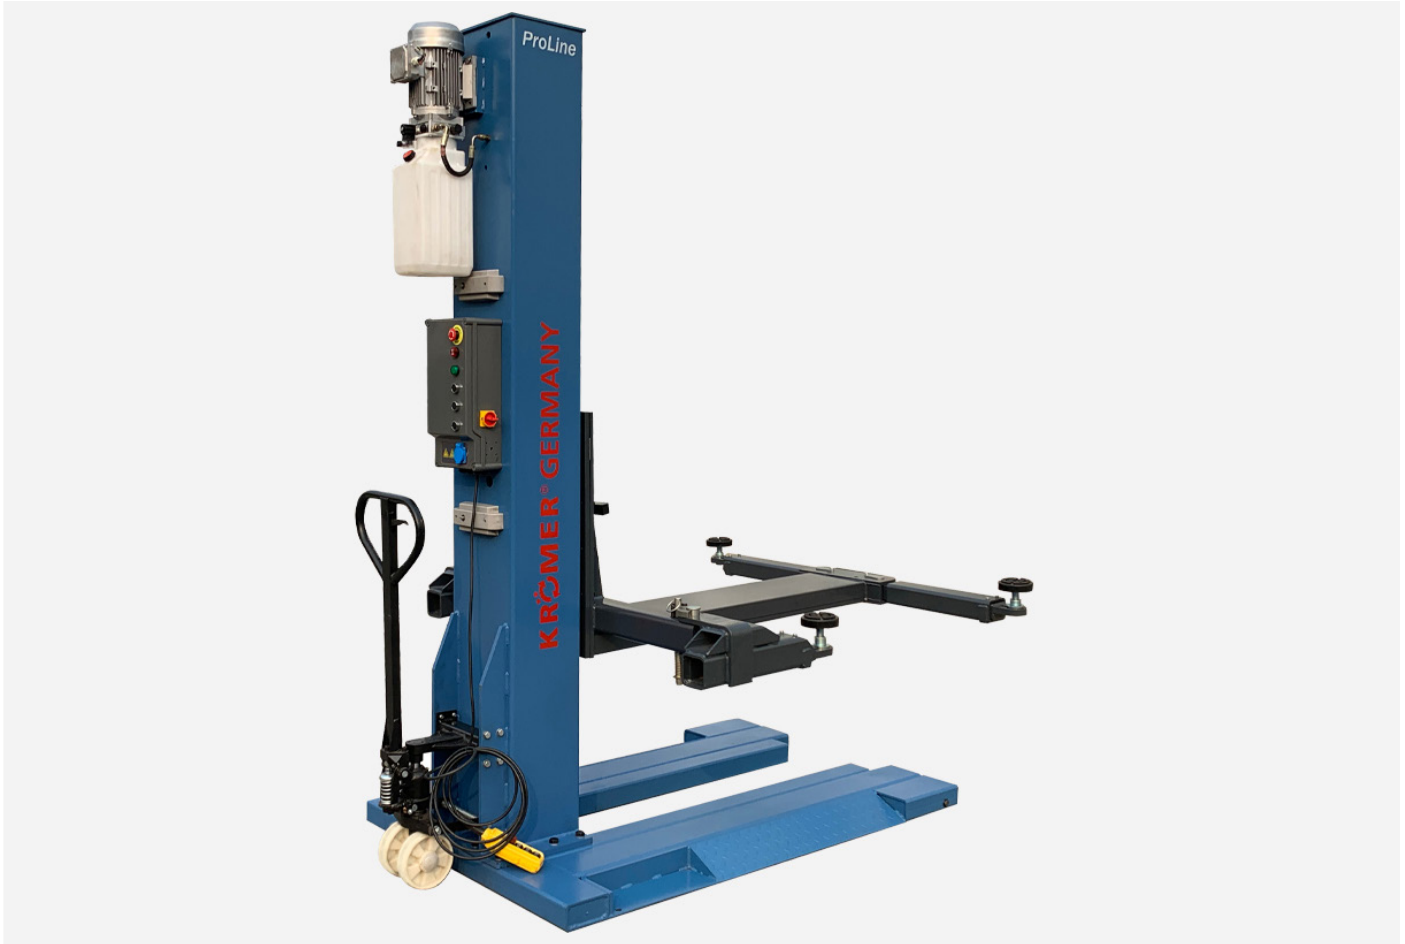
Cause: Loose connectors

Solution: Stabilize electrical cable connections to the magnets of the safety catches - to the magnets of the release valve and the limit switches with cable ties.

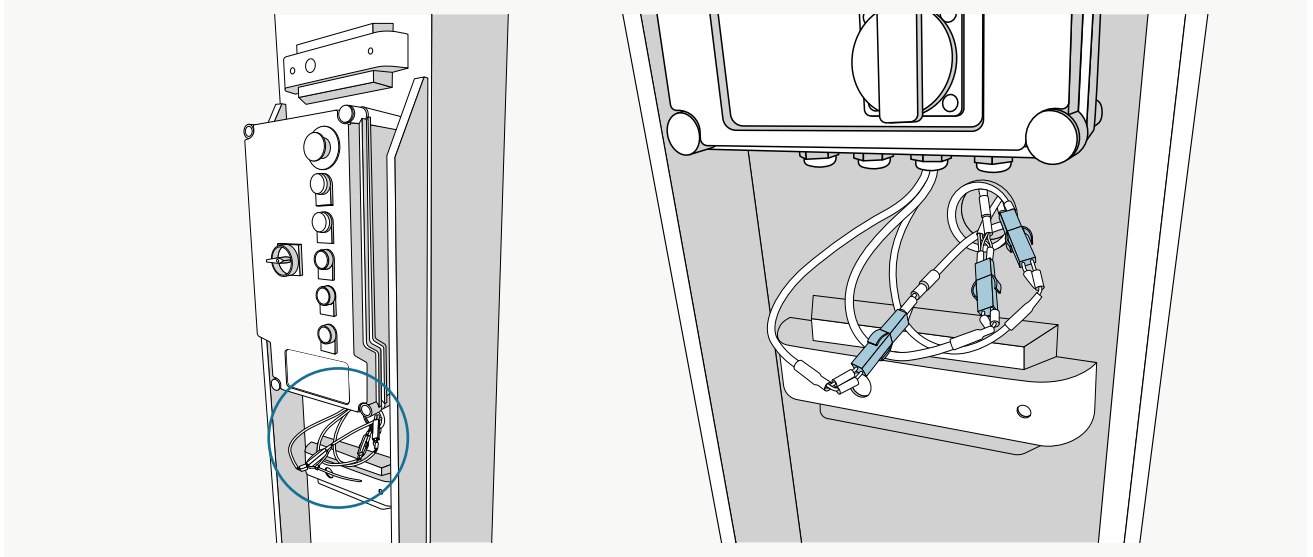
1 Expose connections - if necessary

The relevant connections run below the control panel into the column.
